IDR Sheet	1	of	2	Sheets	Final Record Book	Page
Contract		Day			Date	
C-7852		Wednesday			June 23, 2010

DIARY - Including but not limited to: a report of the day's operations, time log (if applicable), orders given and received, discussions with contractor, and any applicable statements for the monthly estimate.

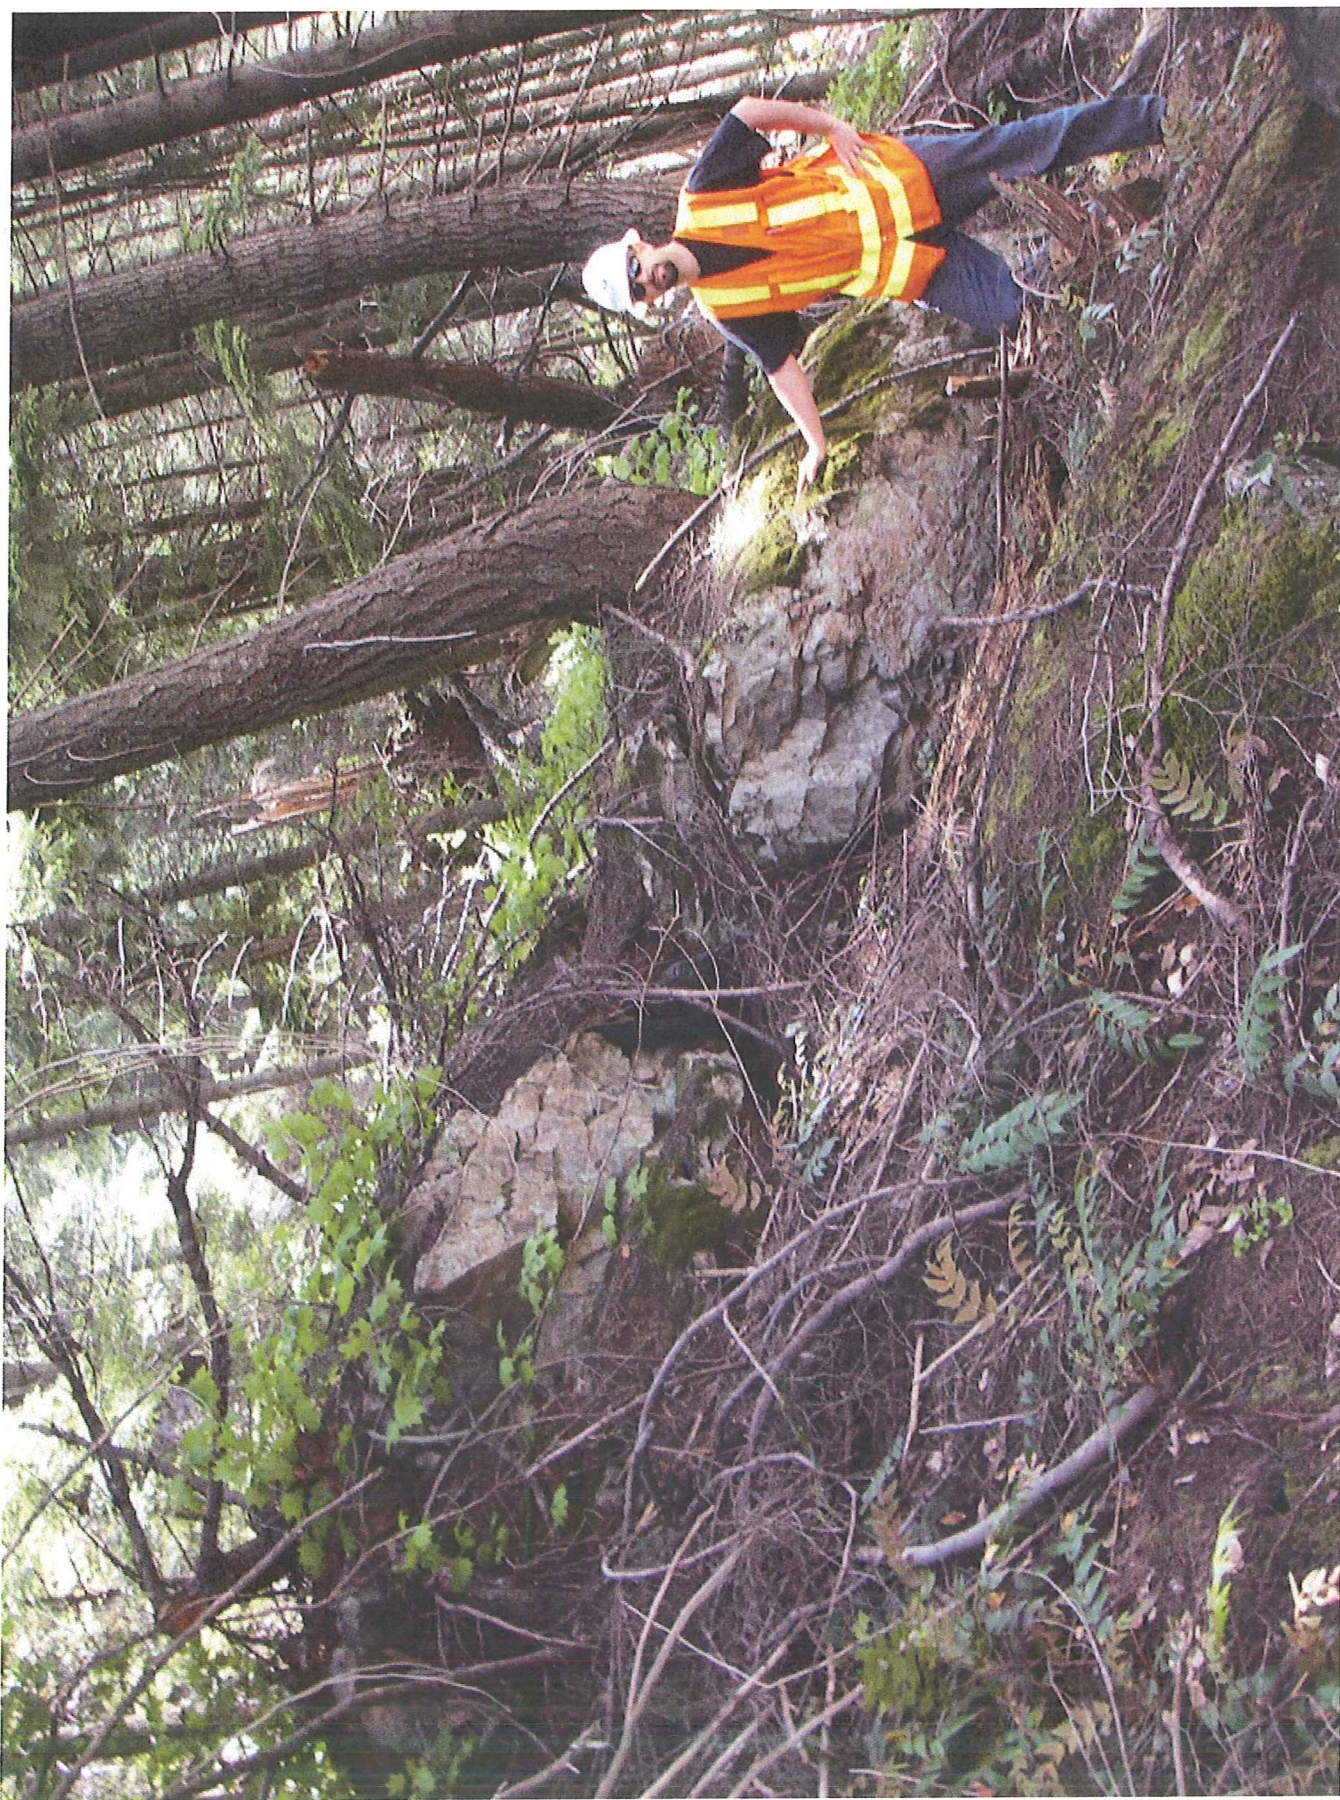
Brad indicated an additional location that may need to be scaled before blasting operations around station LW 1340+25. Gabe and I inspected this location and found a few nested boulders that ranged from 5 to 15 feet in dimension and were located approximately 100 to 125 feet upslope from the proposed centerline (Figure 1). The boulders were located on the slope with vegetation and a tree growing around/on the rock blocks that indicated that these boulders have not moved recently. The natural slope that the boulders rested on was around 25 to 30 degrees and no rockfall was observed in the near vicinity. I indicated to Brad that these rocks did not need to be scaled prior to blasting operations; however, he should visually inspect the area following each blast and contact the Geotechnical Division if it appears that the rock blocks have moved.

Figure 1. A photograph of the nested boulders located at approximate station 1340+25. Note the vegetation growing on and around the boulders.

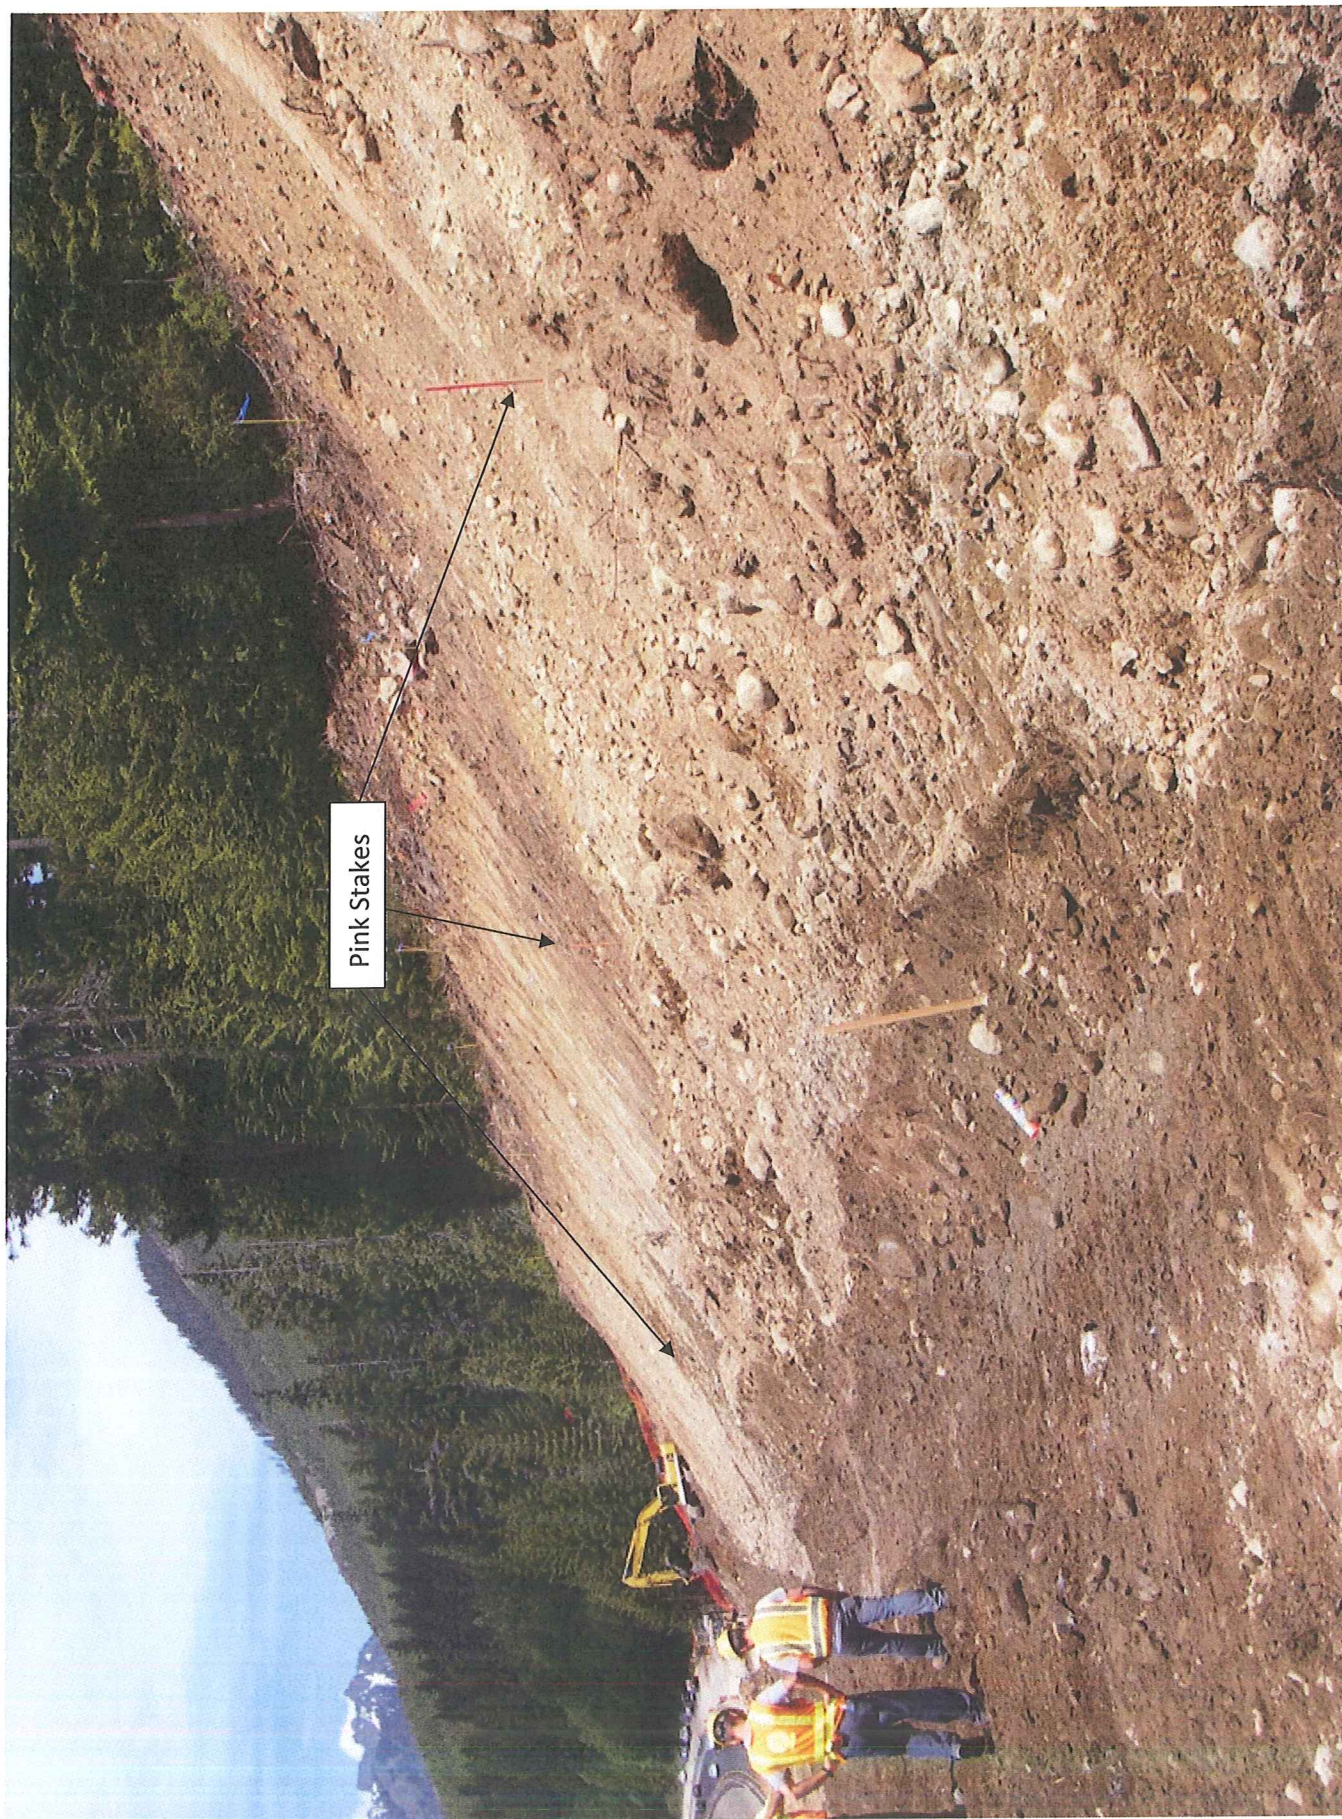
Following our inspection of the rock blocks at station LW 1340+25, Jerry Wood and Brad requested that we take a look at the overburden located between stations LW 1316+00 to 1320+00. When we arrived, the contractor was attempting to locate the top of bedrock so they could start laying back the overburden at the designed 1.50H:1V orientation. According to the contractor, the bedrock was lower than anticipated. Gabe and I both noticed that the equipment was attempting to locate the top of rock 10 to 20 feet from the compound cut hinge line (Figure 2). I indicated to Jerry and Brad that the top of rock needed to be located at the hinge line location, and regardless if it is deeper than anticipated, we needed to find that location and then locate the overburden catch upslope from there, probably chasing further upslope. Jerry indicated that this would be acceptable but he did not want to chase the cut too far upslope. I contacted Tom Badger requesting that we steepen up the overburden orientation to 1.25H:1V as it was designed for the eastern portion of the project. I told Tom that the material at the west side was similar to the east side and Tom stated that the steeper orientation was acceptable as long as we did not go steeper than 1.25H:1V. Before Gabe and I left the site, we had the contractor begin excavating test pits at the staked bedrock/overburden hinge point to locate the top of rock (Figure 3). We stayed on site for 3 to 4 of these test pits until everybody was on the same program as how and where to locate the top of rock.

Figure 2. A photograph looking at the overburden section from approximate station 1316+00 to 1320+00. Notice the pink stakes are showing the rock/soil hinge point location.

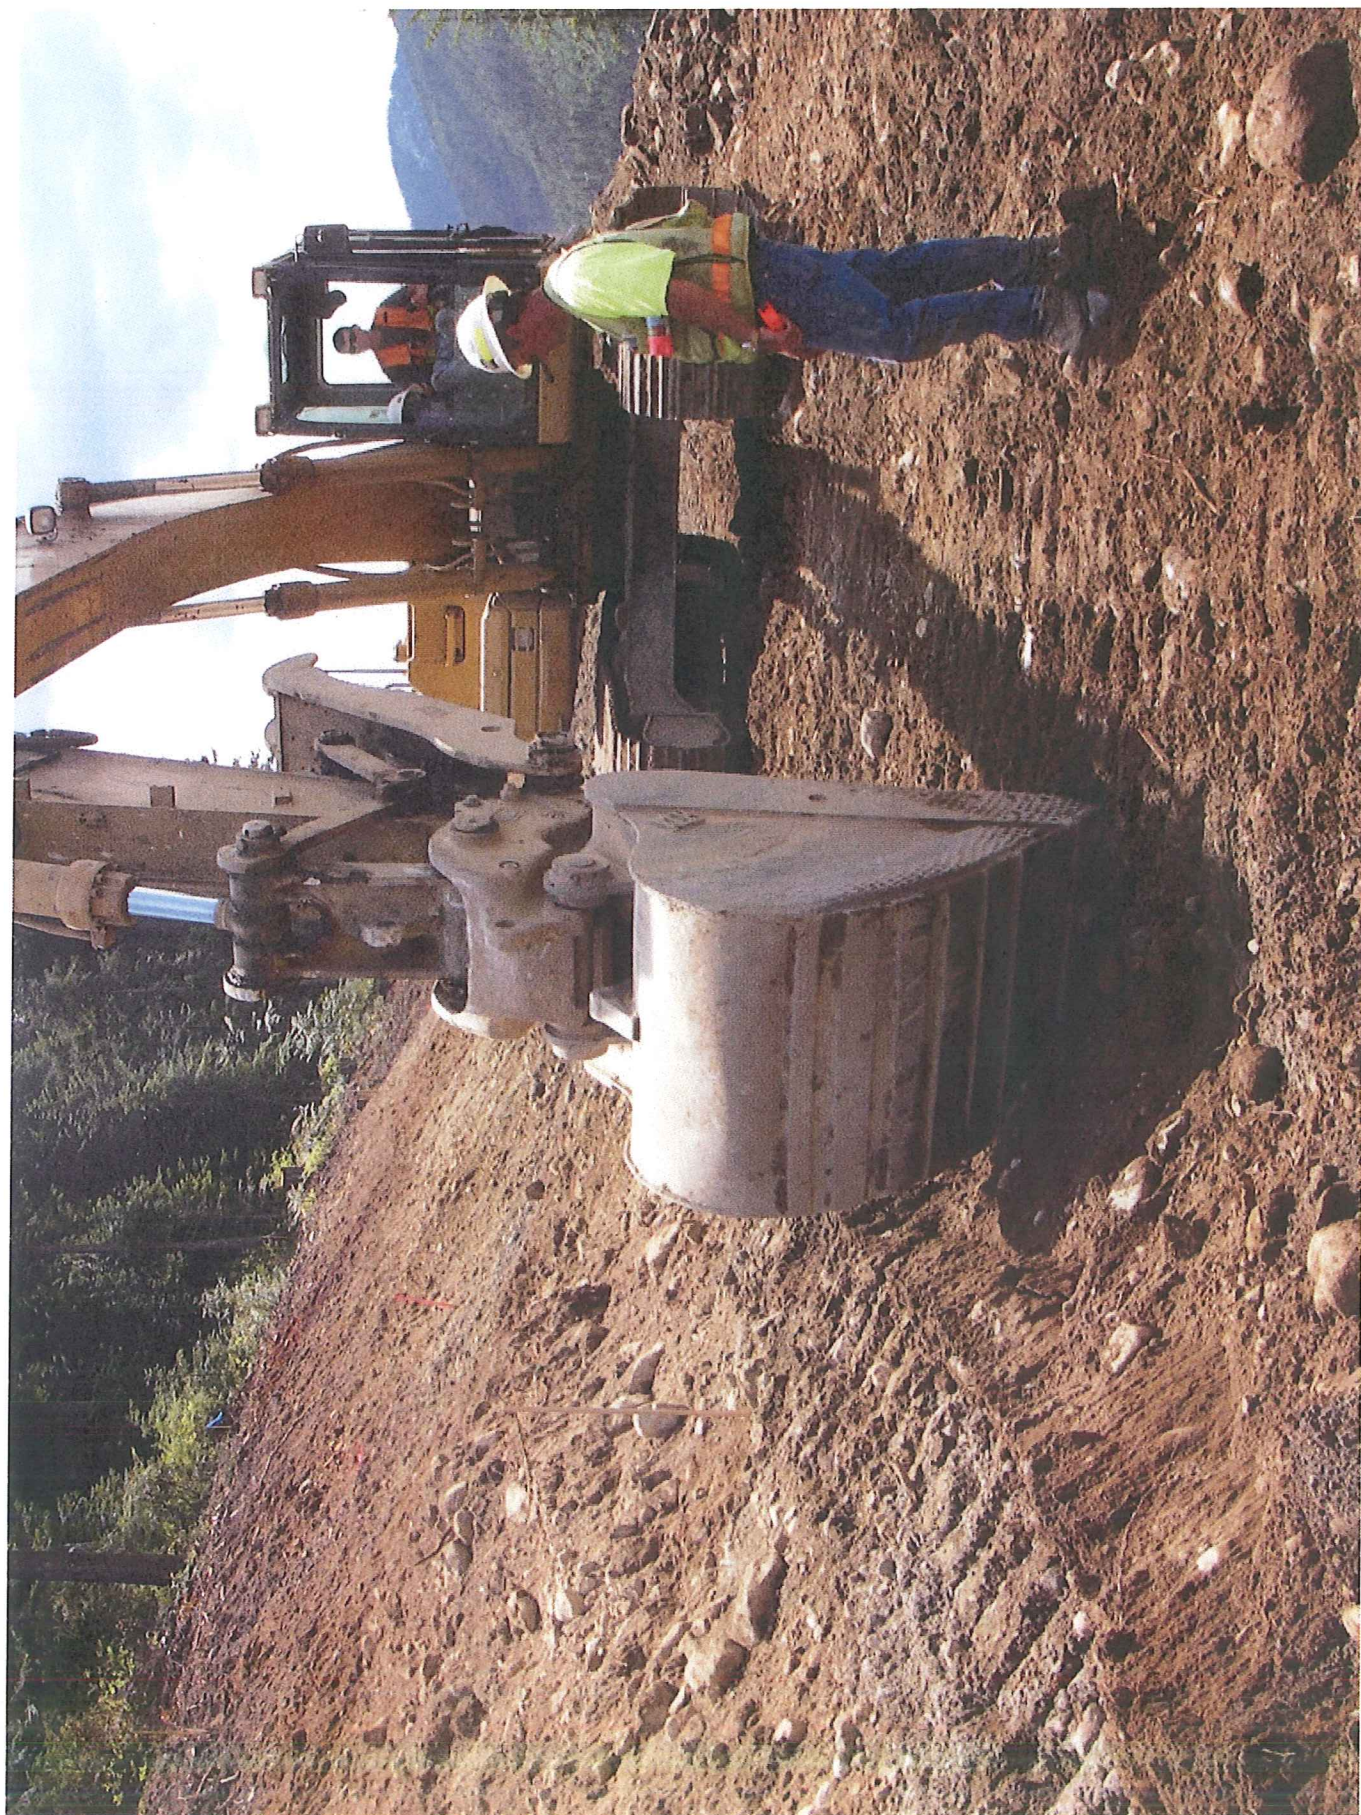
Figure 3. A photograph showing the excavator digging test pits to locate the top of bedrock.
